AIRCRAFT ACCIDENT REPORT

UNITED AIRLINES FLIGHT 2885,
N8053U, McDONNELL DOUGLAS DC-8-54F
DETROIT, MICHIGAN
JANUARY 11, 1983

NTSB/AAR-83/07

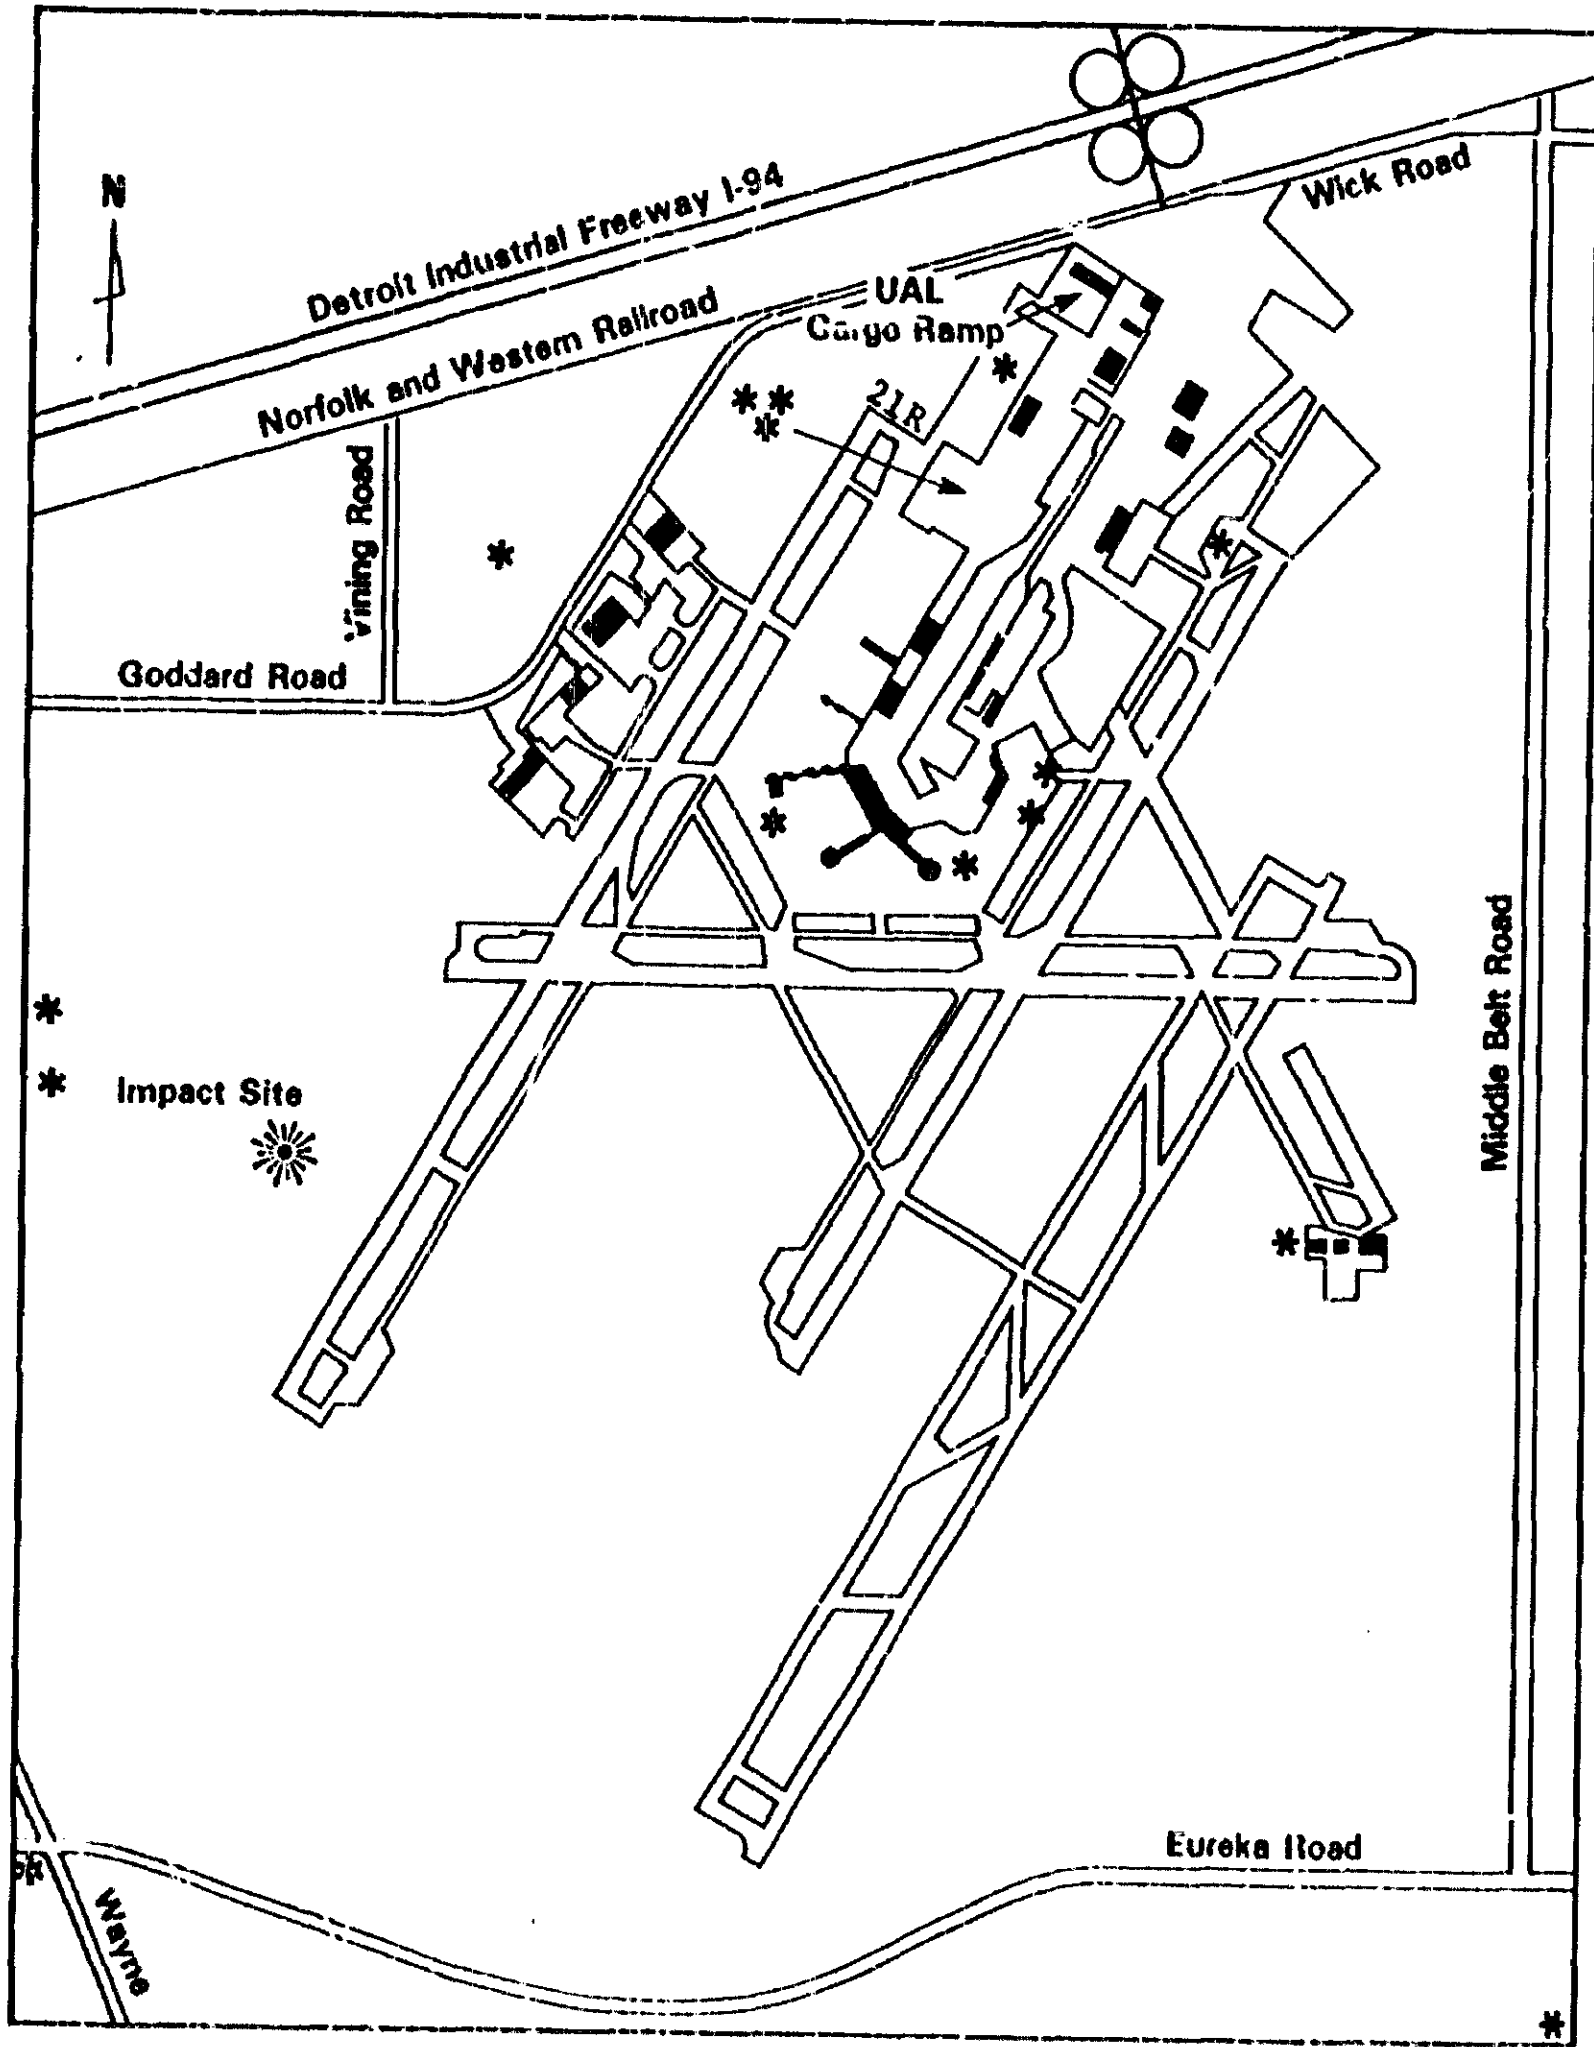
Figure 1.--Detroit Metropolitan Wayne County Airport runway/terminal layout, accident site, and witness locations.

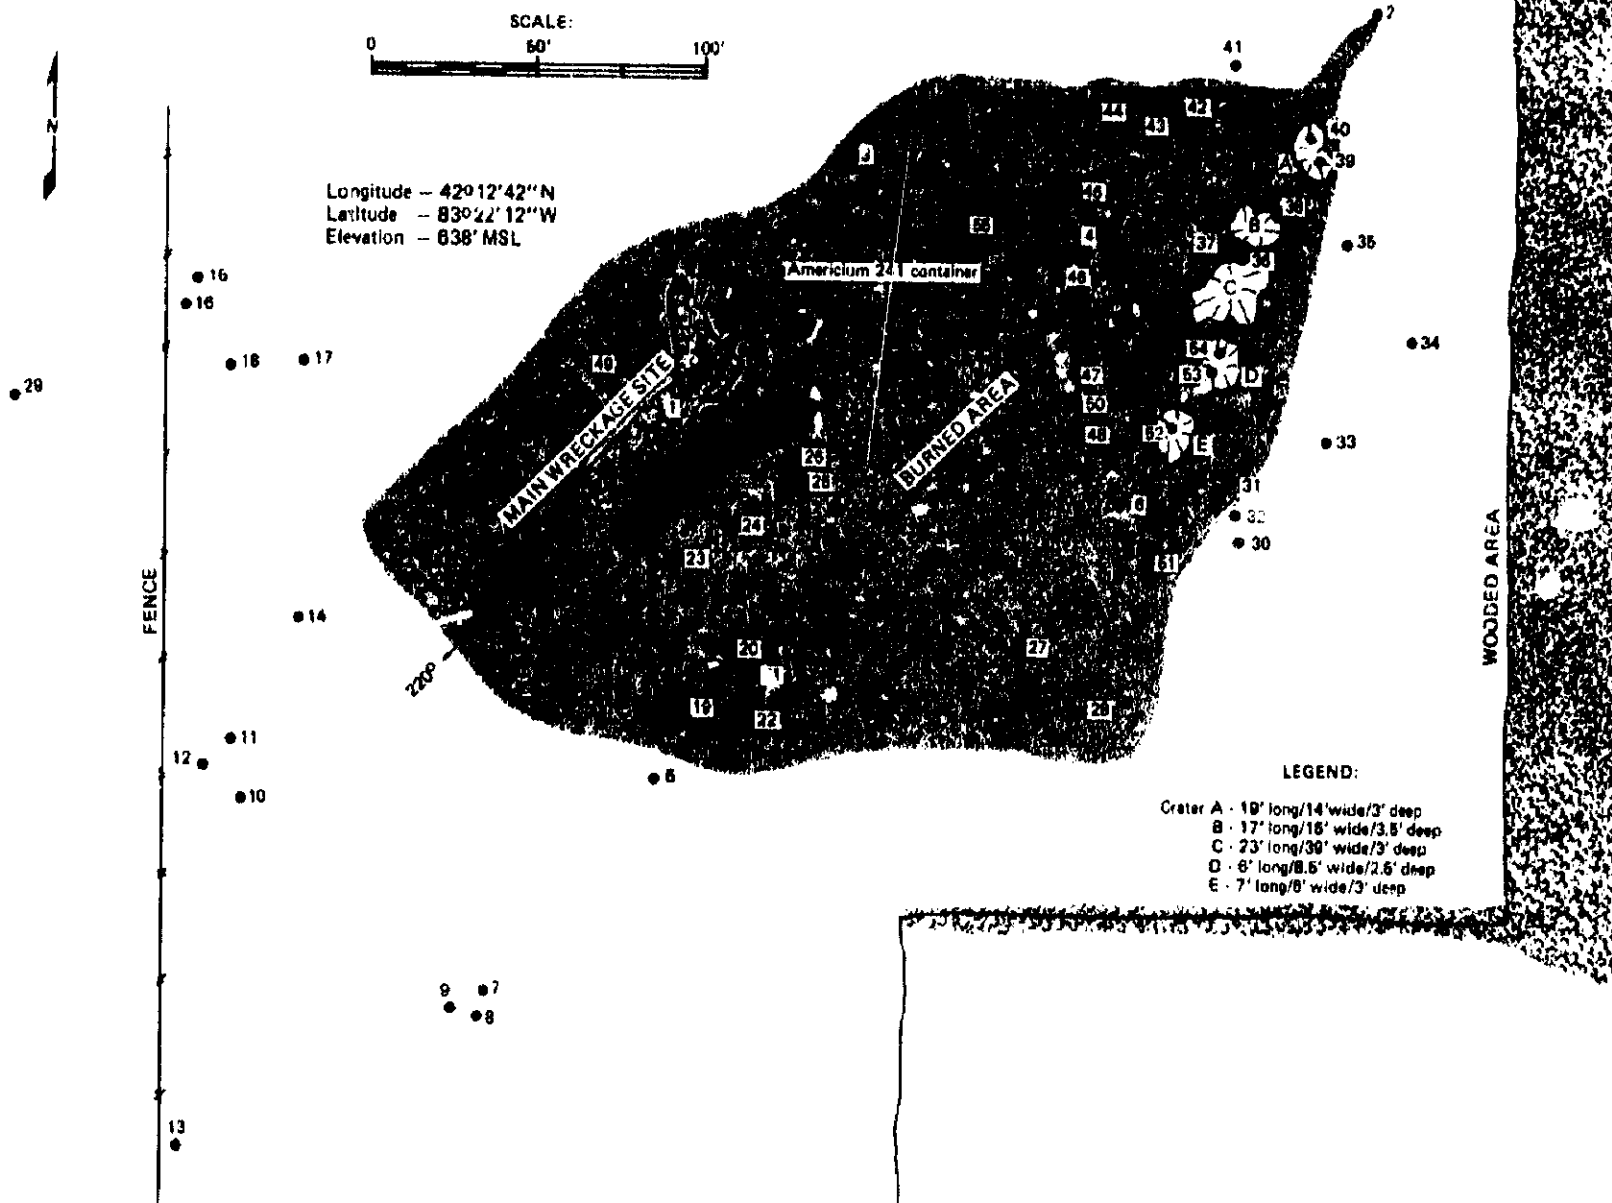
APPENDIX D WRECKAGE DISTRIBUTION

WRECKAGE DISTRIBUTION OF PARTS

1. 70' section of aft fuselage and empennage assembly.
2. Pieces of red and clear glass (wingtip lighting).
3. No. 1 engine.
4. No. 2 engine.
5. No. 3 engine.
